**US Army Corps
of Engineers**
Construction Engineering
Research Laboratory

SPECIAL REPORT M-360
September 1984

**REVIEW OF SIDING MATERIALS FOR TURNKEY PROCUREMENT
OF ARMY FAMILY HOUSING**

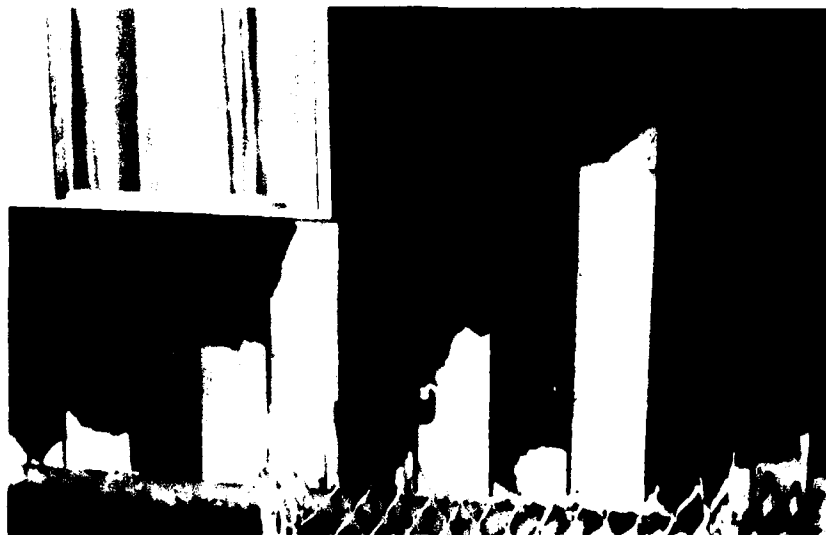
Fort Hood, TX was visited to view some hardboard siding that was reportedly failing badly. This siding is a reverse board-and-batten style called "Insulite" and is manufactured by Boise Cascade. The manufacturer's warranty on the material is 5 years. The siding inspected was in very poor condition, with much swelling, warping, and delamination (Figures 5 through 8). It is literally popping off the wall.

Figure 7. Another type of hardboard failure at Fort Hood. The hardboard finish has peeled off.

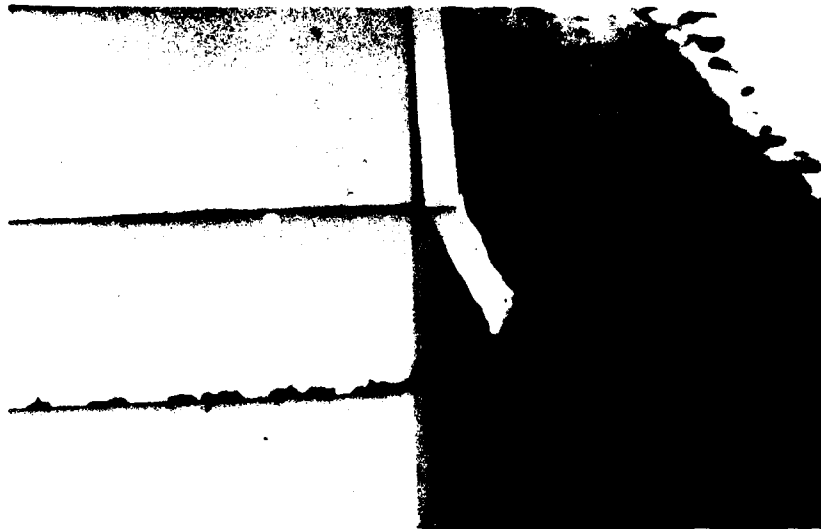
Figure 11. Fading and chipping of hardboard siding. The degree of fading is obvious by comparing the surface previously covered by a cornerpiece with the rest of the panel.

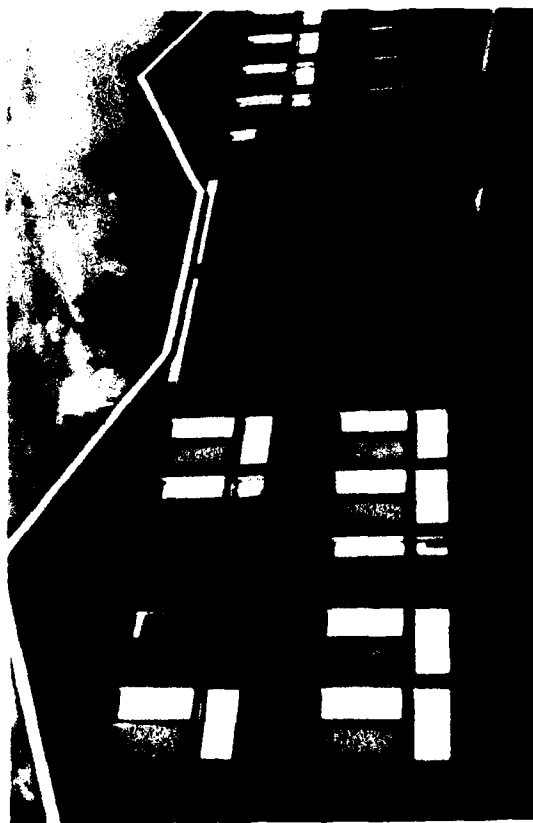
Figure 12. Successful brick and hardboard application at Fort Drum, NY.

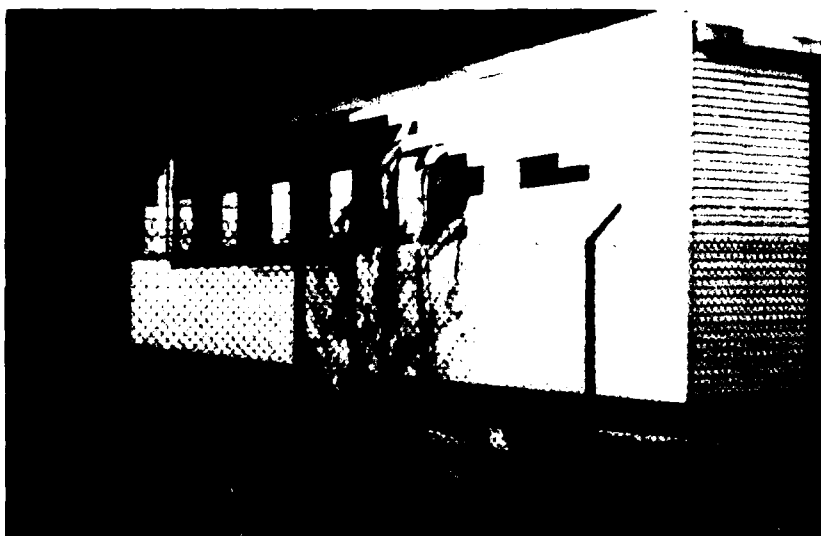
One building had had several courses of siding blown off during a wind storm (Figure 16), although this also was thought to be easy to repair. On some other buildings, the last piece of siding at the top of the wall had come loose from the finish trim; this may be due to improper crimping of the siding before it is slipped into the trim.

Figure 16. Wind-damaged vinyl siding at Fort Devens, MA.

8. A snap-lock punch must be used to crimp the siding for a tight lock into the undersill or finish trim. This helps insure the panel will not come loose at this point during high winds.
